# *Analysis Of Reliability Pressure Regulated Valve Engine Rolls Royce Trent 700 On Airbus 330-300/200*

**Abstract** – Engine bleed valve or pressure regulated valve is one of the components in the engine bleed system which is located on the aircraft engine. This component is based on data removal of the pressure regulated valve component from PT. XYZ. Research using the fishbone diagram method and Why analysis is used to find the causes of frequent damage to PRV components. Then the Weibull distribution method is used to obtain the failure rate and reliability level of PRV components and determines the MTTF (Mean Time to Failure) value used to determine the schedule effective treatment. After evaluating the reliability using the Weibull method, the MTTF value of the pressure regulated valve was 9161.438 FH, the most common cause of PRV unshedule removal was not closed PRV which was caused by damage to several components such as butterfly valve corrosion, carbon actuator, spring, body actuator, piston, and piston guides.

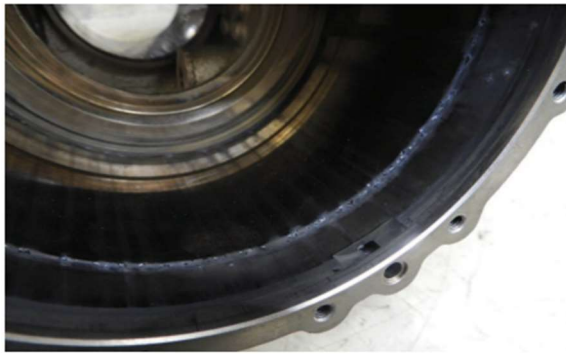
Materials are factors from within the PRV such as component lifetime and conditions when operating components at high temperatures and pressures continuously coupled with vibrations from the engine cause damage to several subcomponents such as butterfly valves experiencing corrosion, and damage to carbon actuators, springs, actuator bodies, pistons, guide pistons.

Fig 7. Actuator internal corrosion

| 6. | Why is material a problem for the pressure-regulated valve not closing? | Because some PRV components such as butterfly valves experience corrosion, and damage to the carbon actuator, spring, actuator body, piston, and guide piston. | 1. Properly conditioning the storage area, namely good humidity control and covering the PRV that is detached from the engine. | Results of interviews and brainstorming with Airbus A330 type rating engineers |

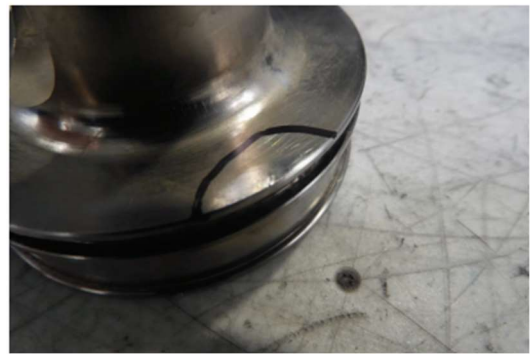
Fig 8. Actuator piston blistered

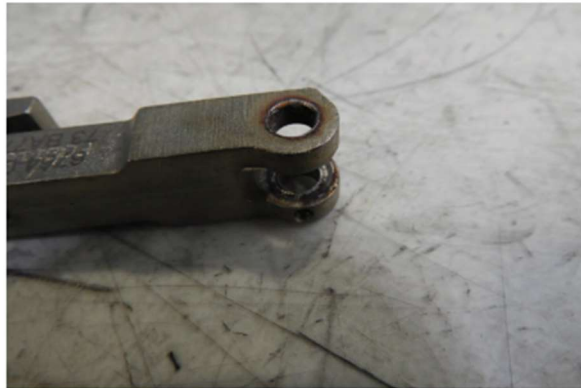
Fig 9. Kinematic corroded

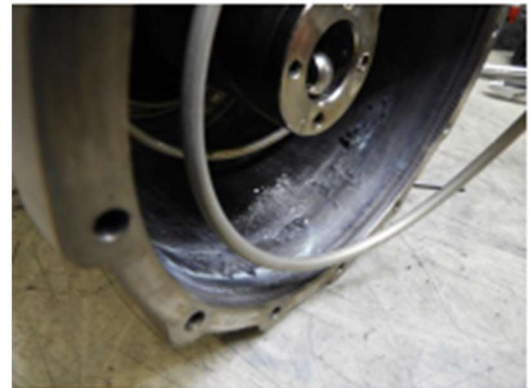
Fig 10. Actuator S/A - Actuator internal corrosion
