Vol. 35 No. 1 October 2022, pp. 150-158

The Effect Of Immersion On The Post-Impact Bending Strength Of A Polyurethane Rigid Foam Sandwich Composite With Bamboo-Fiberglass Woven Reinforcement

Agus Dwi Catur¹, Made Wijana²

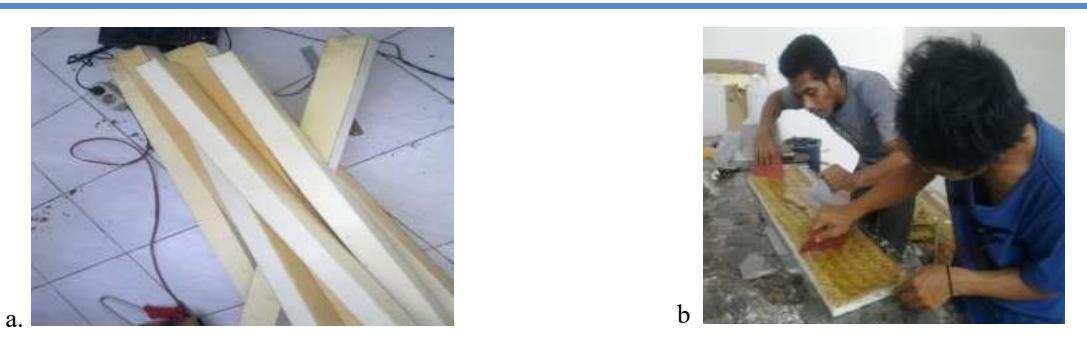
Figure 1 Making sandwich composites: a. cutting polyurethane rigid foam sheet as the core b. sandwich composite core laminate.

In the research in this paper, the object of research is a sandwich composite with polyurethane rigid foam sheet as the core. The two sandwich composite skins are made of laminated polyester with a hybrid reinforcement of *gigantochloa apus* bamboo woven and fiberglass woven. The making of bamboo strips uses a thin cutter to separate the outermost and innermost skins so as to obtain a strip thickness of 1 mm with a width of 10 mm. The bamboo strips are woven at an angle of 45^{0} and -45^{0} to form a sheet of bamboo woven for further cutting according to the dimensions of the specimen. The bamboo woven were soaked in 4% NaOH solution for 2 hours. This alkaline treatment aims to remove lignin on the bamboo surface so that the interface bond between the fiber and the polyester matrix is better. After alkaline treatment, the bamboo woven were dried in the sun for 1 day. Bamboo woven weight has an average weight of 576 gr/m². Another laminate reinforcement is fiberglass woven with a weight of 200 gr/m². The polyurethane rigid foam sheet (PURF) was cut to the size of the sandwich composite specimens (Fig. 1a).

The manufacture of sandwich composite skin is done by laminated polyurethane rigid foam sheet (Figure 1b) with polyester resin with a hybrid reinforcement of bamboo woven (B) - fiberglass woven (F). The number and arrangement of reinforcement are varied according to the planned formation. For the formation of the 2F/1B-PURF-1B/2F sandwich composite, the polyurethane rigid foam sheet is sandwiched by a laminated polyester reinforced with 2 sheets of fiberglass woven -1 sheet of bamboo woven for each of the top and bottom skin of the sandwich composites. In the 2F/2B-PURF-2B/2F sandwich composite formation, the laminated polyester reinforced with 2 sheets of bamboo woven for each top and bottom skin of the sandwich composites of bamboo woven for each top and bottom skin of the sandwich composites flank a polyurethane rigid foam sheet. While the 3rd formation of sandwich composites is 3F/1B-PURF-1B/3F, namely polyurethane rigid foam sheet flanked by laminated polyester- three fiberglass woven sheet and one sheets of bamboo woven.

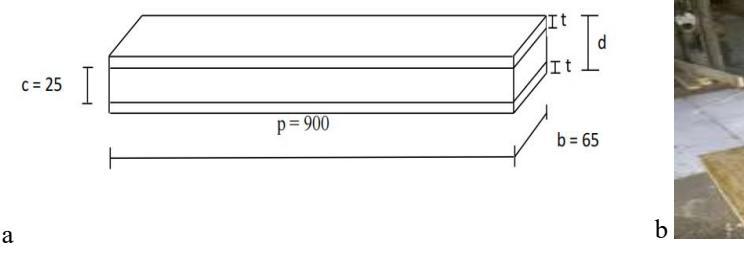
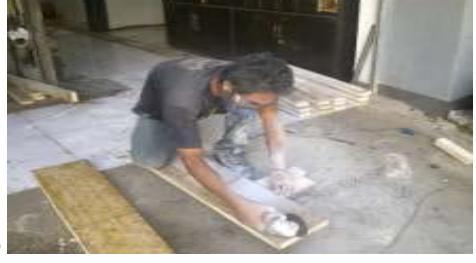
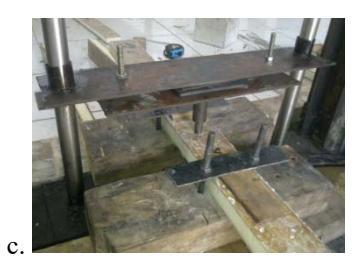
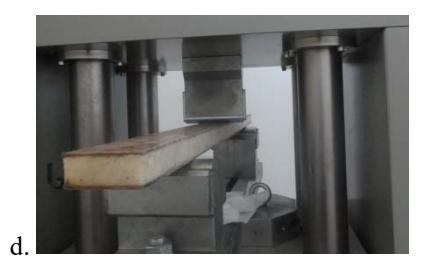
Figure 2 Specimens and test equipment; a: specimen size (mm),b: cutting specimen,c: dropweight impact test tool,d; three-point bending test

The two laminates that have been glued flanking the core are then allowed to dry in the room. The sandwich composite has been finished and is ready to be cut using a high speed grinder (Figure 2b) to be made into specimens that are ready to be tested. Referring to the ASTM C 393-00 standard, the dimensions of the composite sandwich test specimen are rectangular in shape (Figure 2a). Where the width must be not less than twice the thickness of the core. The length of the specimen must be equal to the length of the span plus 50 mm (or 2 inches). To ensure that the simple sandwich composite theory applies the rule of thumb for the three-point bending test, the span length divided by the sandwich thickness must be greater than 17.

Falling load impact method using a dropweight impact test tool (Figure 2c). Dropweight impact loading was carried out by applying a shock force to the surface of the composite skin in another study to determine the ability of the skin and core sandwich composite to withstand shock loads. The dropweight impact treatment in this study was intended to provide defects on the surface of the sandwich composite skin so that seawater could enter and further affect the exposed bamboo fibers during immersion. This is to cause defects in the composite by impact, with the analogy of a sandwich composite boat receiving an unexpected impact when using the boat at sea.

The type of bending test carried out is three-point bending by applying a bending force slowly in the middle of the specimen supported by roller supports at both ends of the specimen (Figure 2d). The bending test standard is ASTM C 393-00. From this bending test, it is known that the bending force of the composite can withstand the load until the composite breaks or the bending load decreases drastically. Prior to the bending test, the dimensions of the specimen were measured, shifting the bending pedestal so that the distance between the supports is 760 mm and the penetrator is in the middle of the distance between the supports. Bending specimens were placed on a universal testing machine and tested by bending at three points with a deviation speed of 5 mm/min. The magnitude of the addition of bending load and bending deflection that occurs in the specimen is recorded and can be seen on the computer monitor.

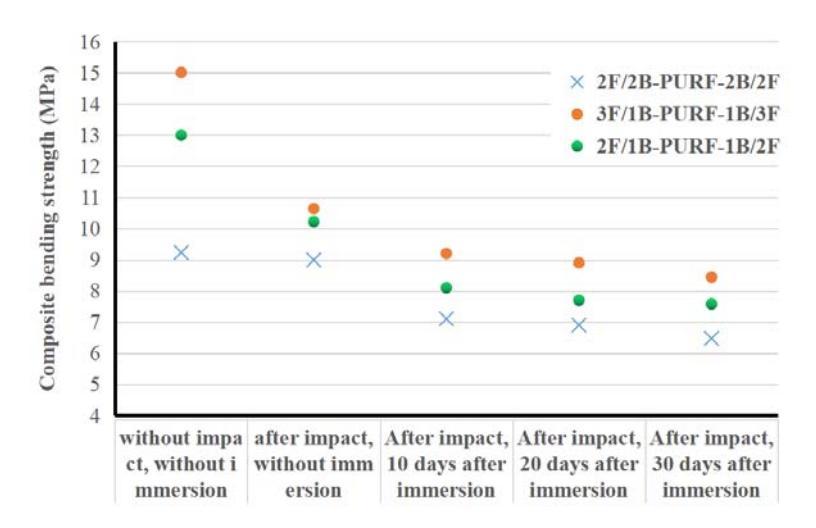
Figure 3 Graph of sandwich composite bending strength before and after impact and after immersion

To calculate the bending strength of sandwich composites, the composite dimension measurement data and the maximum composite bending force in table 1 are applied to equation 1. The composite bending strength values obtained from the three sandwich composite formations, before and after being treated by impact and immersion in seawater are shown in the figure. 3. From figure 3 it can be seen that there are several factors that affect the value of the bending strength of sandwich composites i.e. the effect of variations in the composite skin constituent layers, the effect of impact treatment and the effect of variations in immersion time.

Impact treatment reduces the bending strength of sandwich composites, this can be seen from Figure 3. The bending strength of sandwich composites with the 3F/1B-PURF-1B/3F formation without impact treatment and without immersion is 15.01 MPa, this is down 29% due to impact treatment to 10.64 MPa. The bending strength of the sandwich composite with the 2F/1B-PURF-1B/2F formation without impact treatment and without immersion was 13 MPa, this decreased by 21% due to impact treatment to 10.22 MPa. Impact also reduced the strength of the 2F/2B-PURF-2B/2F sandwich composite from 9.23 MPa to 8.99 MPa or down 2.6%. The bending strength of the 3F/1B-PURF-1B/3F post-impact sandwich composite is better than the other two formations, this cannot be separated from the role of fiberglass which dominates the reinforcement in the sandwich composite skin. However, the performance of maintaining the original bending strength is better in the composite with the 2F/2B-PURF-2B/2F formation, the dominance of thickness by the bamboo laminate makes the impact only damage a limited area on the surface so that the decrease in post-impact bending strength is only 2.6%.

The effect of immersion with seawater after impact treatment causes a decrease in the bending strength of all sandwich composite formations with the length of immersion time, this can be seen in the trend of the bending strength graph in Figure 3. The after impact bending strength of 2F/1B-PURF-1B/2F is 10.22 MPa. Immersion of this sandwich composite with post-impact seawater for 10 days, 20 days and 30 days caused a decrease in bending strength to 8.1 MPa, 7.7 MPa and 7.58 MPa. On the open surface, the reinforcing fiber and the surface between the fiber - matrix in the sandwich composite skin cause water to easily enter the composite, this is due to the capillarity of water in a narrow gap. Water can have an adverse effect on polymer composites both chemically and physically. Chemically, water affects the chemical structure of the resin matrix and water can lower the glass transition temperature [13]. Physically, water can swell the matrix and cause fiber-matrix separation due to the internal tension between them [14]. This causes cracks in the matrix and the separation of the matrix-fiber interface so that the strength of the composite decreases.

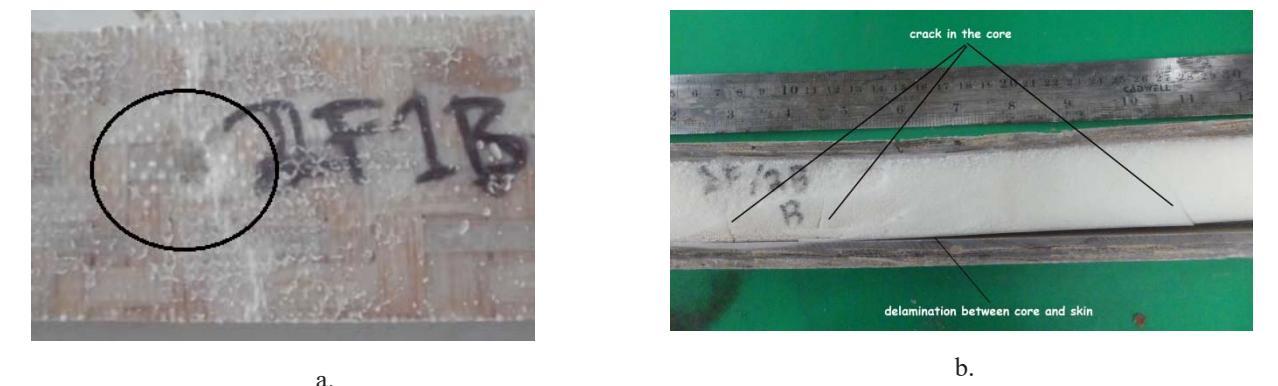
Figure 4. Failure modes on a sandwich composite specimen; a: post-impact defects of the 2F/1B-PURF-1B/2F sandwich formation, b: bending specimen damage after impact of the 2F/2B-PURF-2B/2F sandwich formation

Composites are very sensitive to loads in the thickness direction, especially low velocity impact [11]. The energy of the impact penetrator imposed on the sandwich composite results in the failure/damage of the composite. In the presence of impact energy at a certain collision contact time and the resistance to the impactor causes fluctuations in the impact force, causing damage to the composite. Through the experiment, it was found that the low velocity impact caused damage to the laminated sandwich composite skin. The polymer sandwich composite that received the impact load experienced defects on the surface which continued to the core. Some of the damage modes that occur are: delamination, fiber breaking, matrix cracking, concave surface, even holes or through. Sandwich composite damage due to impact depends on the impact parameters such as the shape and mass of the impactor, impact energy, and the material and size of the composite [10]. An example of a defect that occurs after impact is shown in Figure 4a.

Sandwich composites that have been impacted result in a decrease in bending strength due to the initial defects due to the impact given before the bending test. Impact treatment causes a decrease in bending strength in all variations of composite skins. Impact damage on the three sandwich composite formations caused a significant decrease of up to 29% in the residual bending strength of the material. This is the same as the research of Genghan et al [11], Zhang et al [12] on fiber-reinforced composites, which concluded that the residual strength of fiber-reinforced composites after impact was studied to be reduced. The failure of the after impact bending specimen in the form of delamination between the skin and the bottom sandwich composite core and the occurrence of cracks in the core (figure 4b). This failure occurs because the strength difference and the deformation limit are relatively too far between the skin material and the sandwich composite core. Core to the limit of deformation is not able to transmit the force to the sandwich composite skin. It can be seen in Figure 4b that the crack starts from the bottom of the core

where in this section the tensile stress is more dominant.
